Subject: 40 CFR 761.61 (c) Risk-Based Cleanup and Disposal Request
Former Capewell Manufacturing Facility
70 Popieluszko Court, Hartford, CT

Site Background and History

The Nature of the Contamination

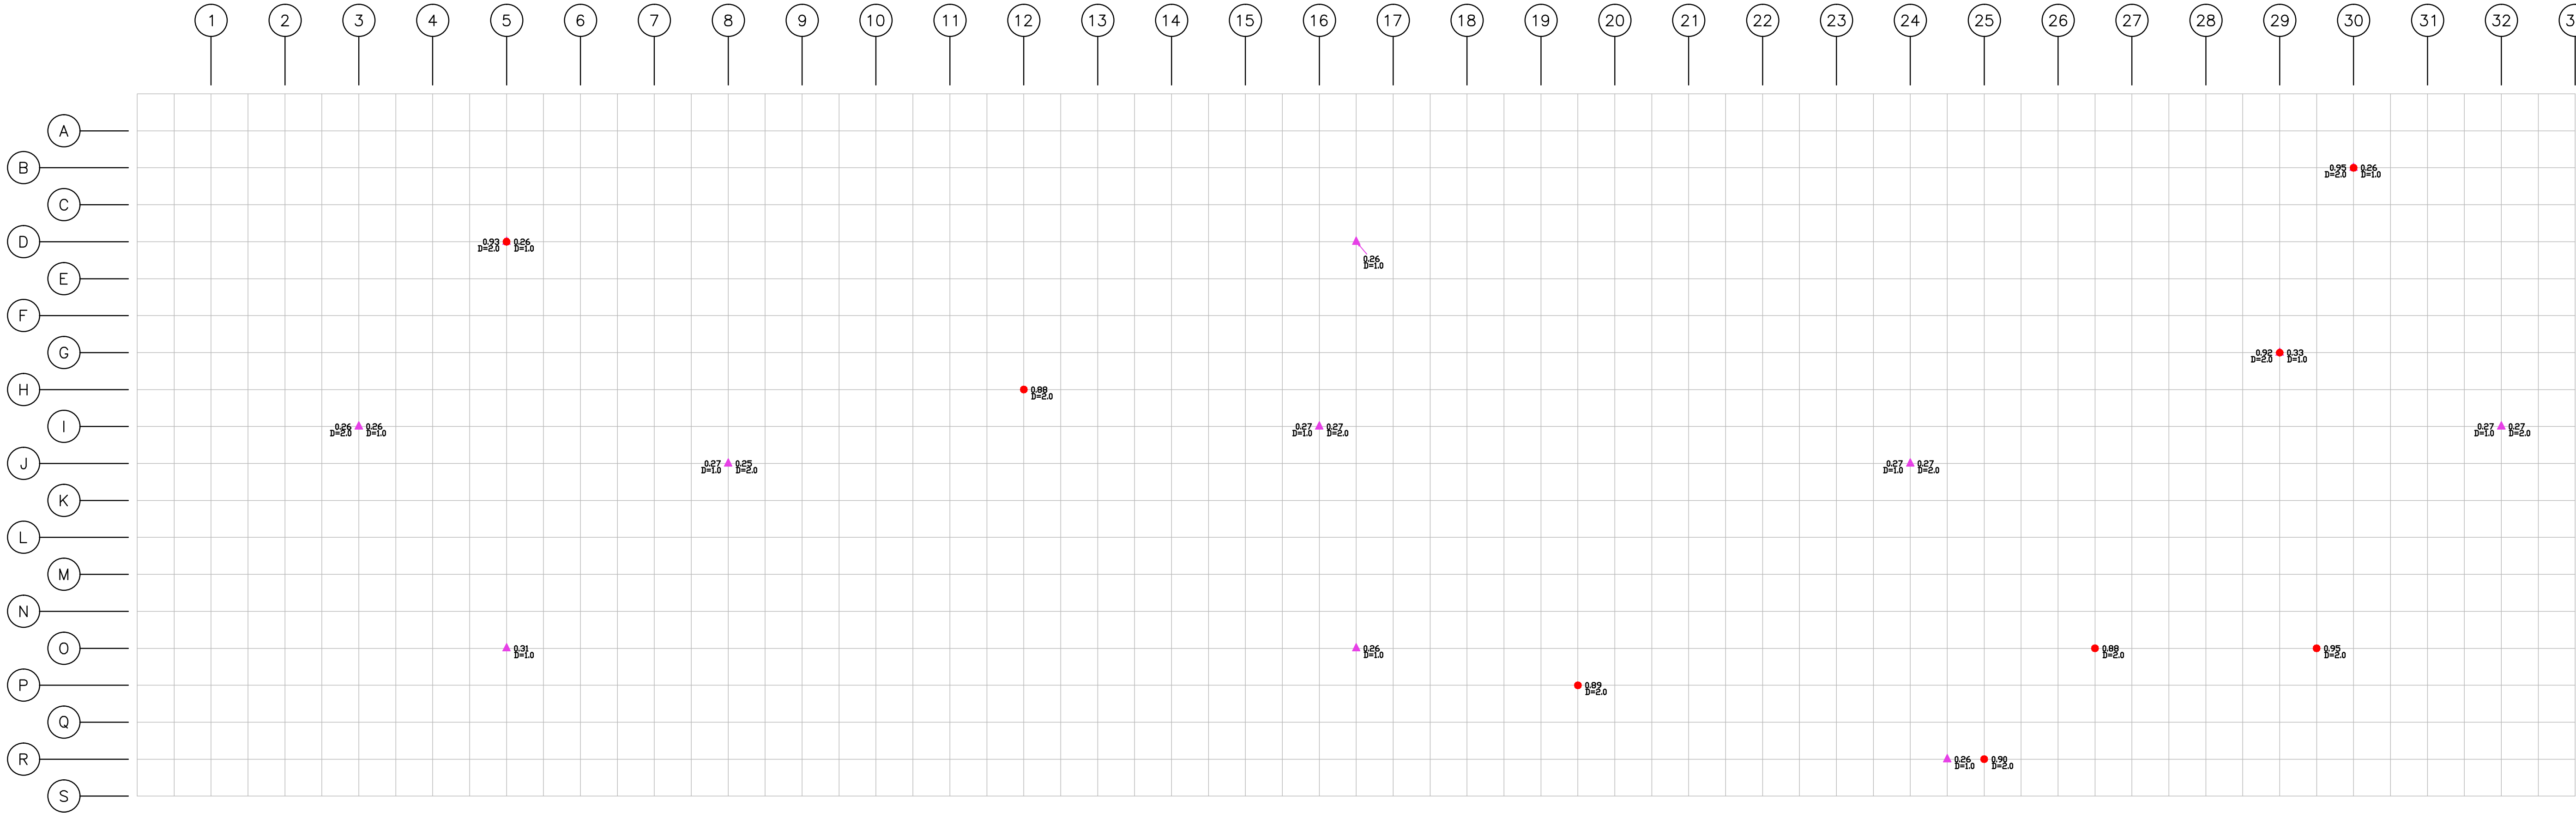
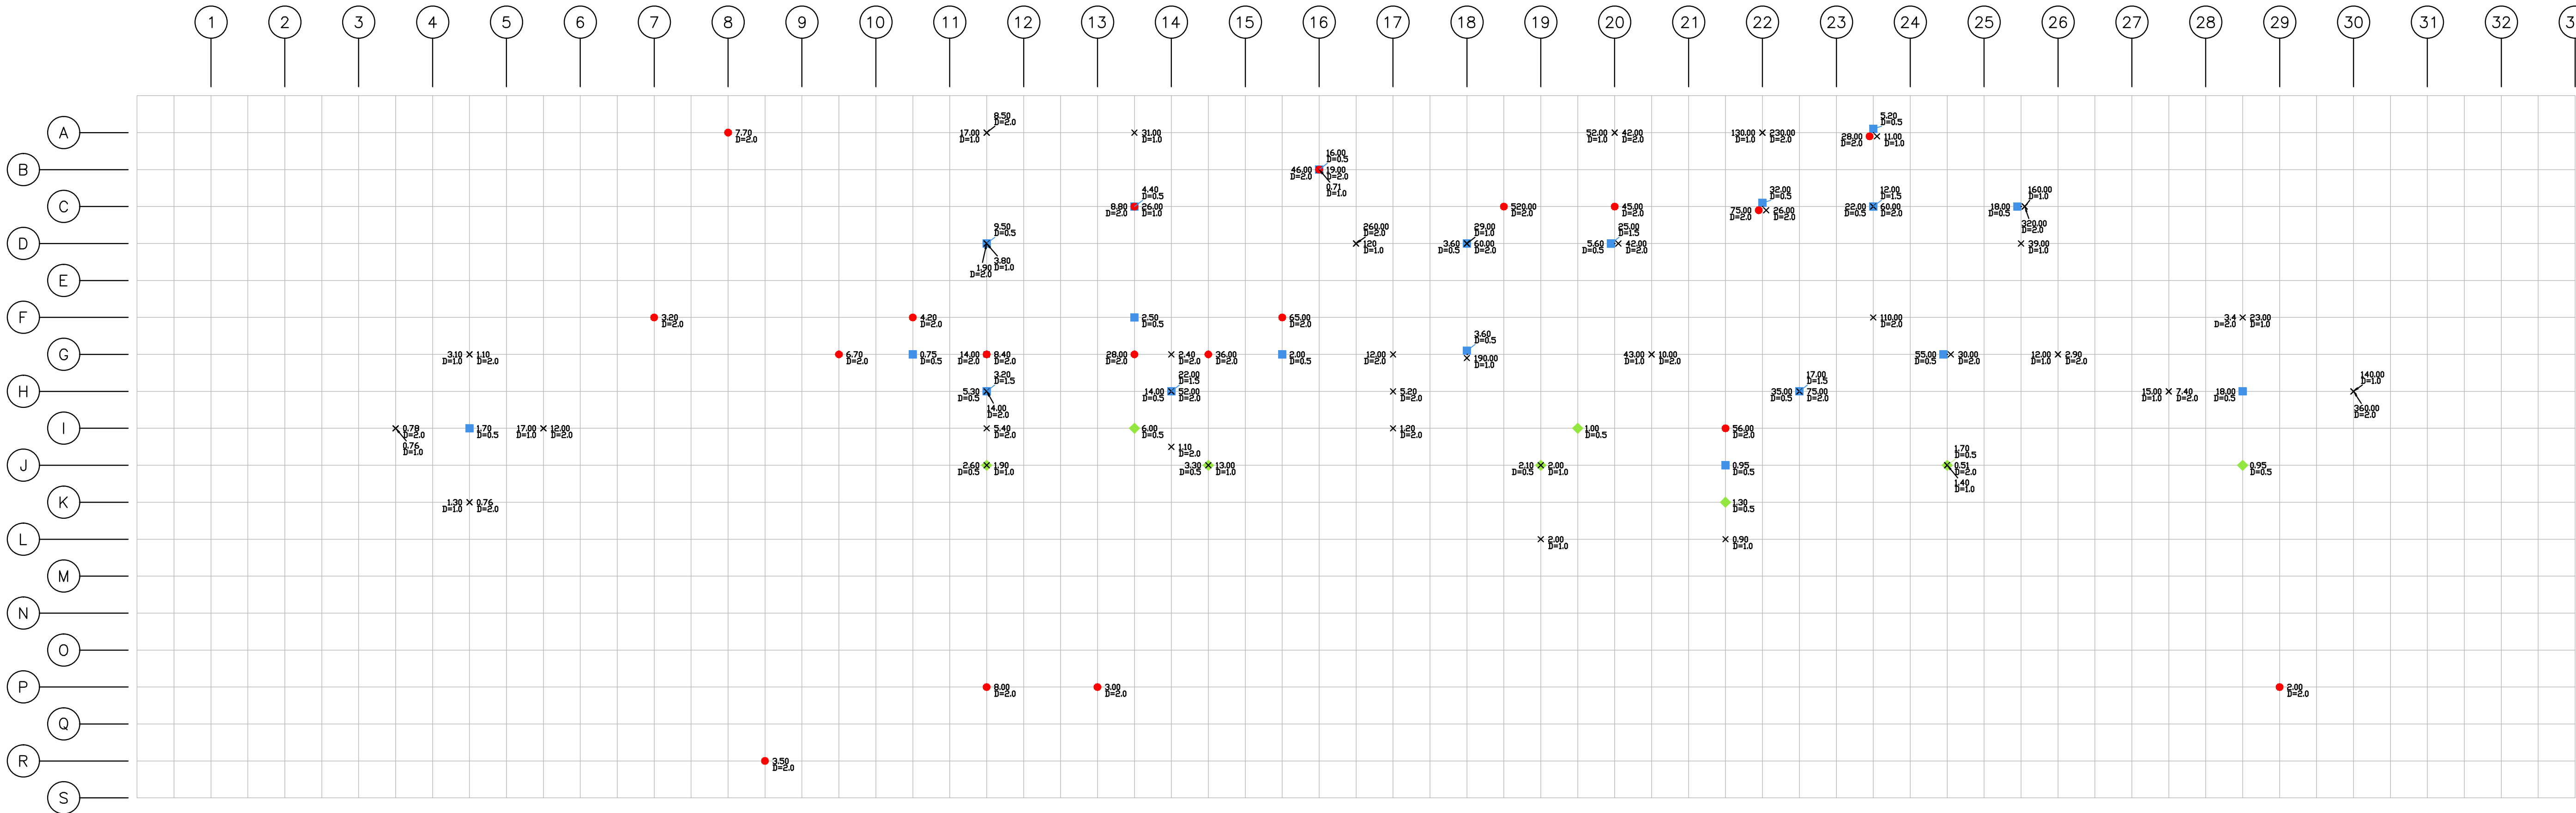
FIRST FLOOR SLAB

SAMPLE DATE	
07/12/1989	●
10/12/2006	■
05/14/2013	◆
06/15/2013	×
07/03/2013	▲

D=Max. Depth of Sample
(All Results Reported
in mg/kg)

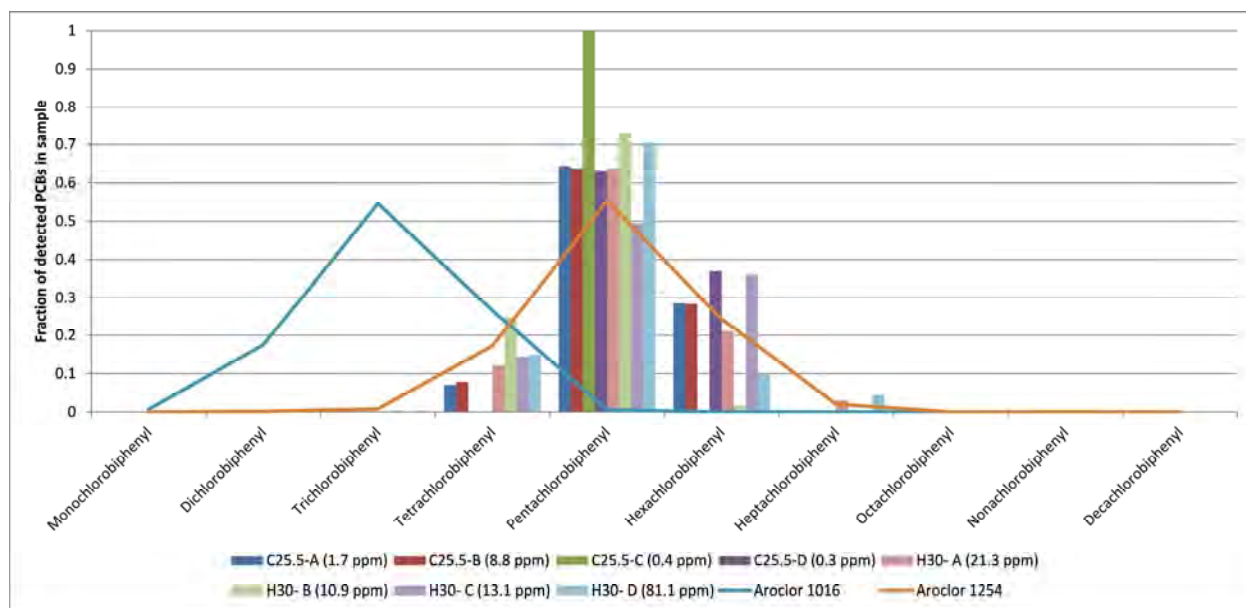
EPA Method 680 was used in 2013 to determine the homologue patterns of PCBs present in the concrete floors in recent samples. Figure 1 compares the homologue groups detected in eight concrete samples (C25.5-A through -D, and H30-A through -D) with the homologue distributions in the Aroclor 1016 and 1254 reference mixtures (ATSDR, 2000). The 2013 samples were collected in two areas of the building's second floor (C25.5 and H30) where 1989 and 2006 sampling surveys identified elevated PCB levels. The bars of Figure 1 indicate the relative fractions of PCB homologues in each concrete sample, and lines reflect compositions of the three Aroclor mixtures. All the concrete samples match best to the homologue pattern of Aroclor 1254, with the pentachlorobiphenyls most prevalent. This observation concurs with the results of 1989 through 2013 SW846 8082A analyses of the concrete floors that have consistently identified the PCBs present as matching Aroclor 1254.

Figure 1 Profiles of PCB homologues detected in concrete samples compared with Aroclor mixtures. Bars plot the relative fractions of PCB homologue groups detected in each sample (normalized to a total of 1). Total concentrations of PCBs in ppm (mg/kg) indicated in parentheses in legend.

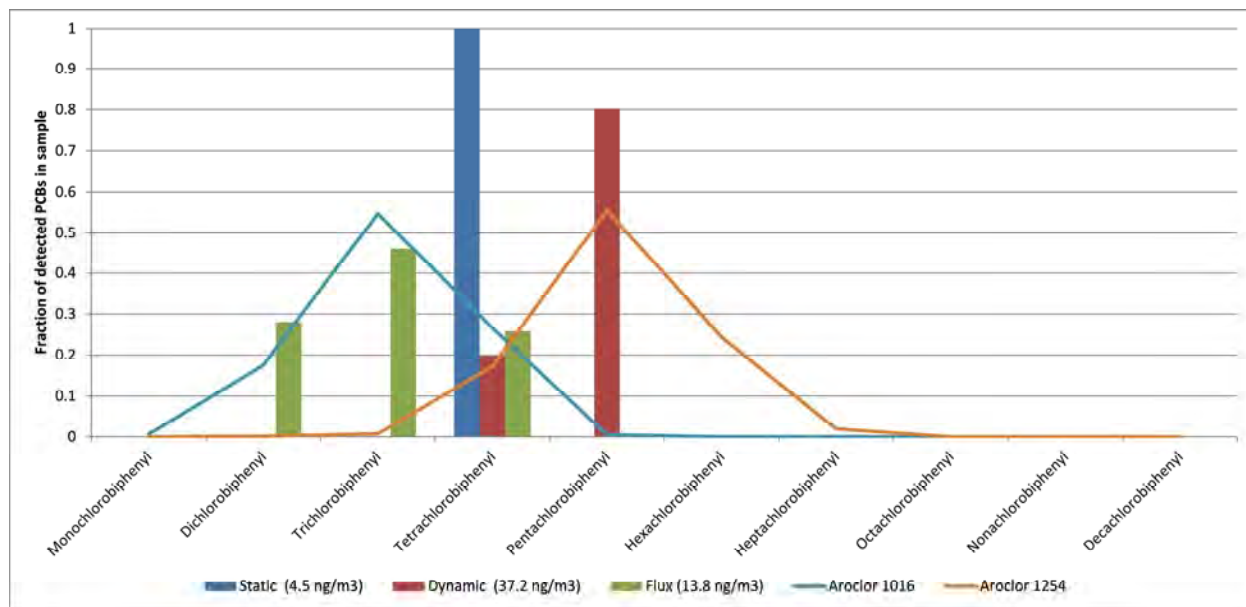
Measurements of PCBs in air collected in the Capewell building in 2013 show that current emissions are of PCBs with homolog patterns shifted towards the less chlorinated homologues. The homologue patterns of three relevant samples are depicted in Figure 2, which like Figure 1, compares the sampled homologue patterns to those of the manufactured Aroclor mixtures (ATSDR, 2000).

Figure 2 Profiles of PCB homologues detected in air sampling at the Capewell building. Bars plot the relative fractions of PCB homologue groups detected in each sample (normalized to a total of 1). Total concentrations of PCBs in ng/m^3 are indicated in parentheses in the legend.

The September 2013 sample results labeled “Static” and “Dynamic” shown in Figure 2 were indoor air samples collected in an enclosure² constructed over the C25.5 sampling area on the 2nd floor of the Capewell building, where the June 2013 concrete sampling survey found 160 ppm and 320 ppm of Aroclor 1254 in 0-1” and 1-2” depths, respectively. No effort was made to clear the floors of the extensive dust and debris prior to sampling. The “Static” sample was collected under still air conditions, while the “Dynamic” sample was collected while a fan was blowing to stimulate air mixture in the enclosure.

Both the higher concentration and resemblance to Aroclor 1254 suggest contamination of the air sample by dust re-suspended by the fan that operated within the enclosure during the “Dynamic” sampling. Since dust and debris within the Capewell building will be removed during renovation, the “Dynamic” sample is not expected to reflect future conditions, and the potential encapsulation of the floor would prevent any generation of dust from the contaminated concrete surface.

The sample labeled “Flux” shows the homologue pattern measured in October 2013 in samples collected with a flux chamber placed on a HEPA vacuumed portion of the H30 sampling areas of the second floor of the Capewell building, where the June 2013 concrete sampling survey found 140 ppm and 360 ppm of Aroclor 1254 in 0-1” and 1-2” depths, respectively. The flux chamber experiment was specifically designed to measure the rate of PCB volatilization off the concrete floor. Only the di-, tri, and tetrachlorobiphenyl groups were detected in the flux sample. The peak in the trichlorobiphenyl homologue group suggests an effective profile similar to that of Aroclor 1016.

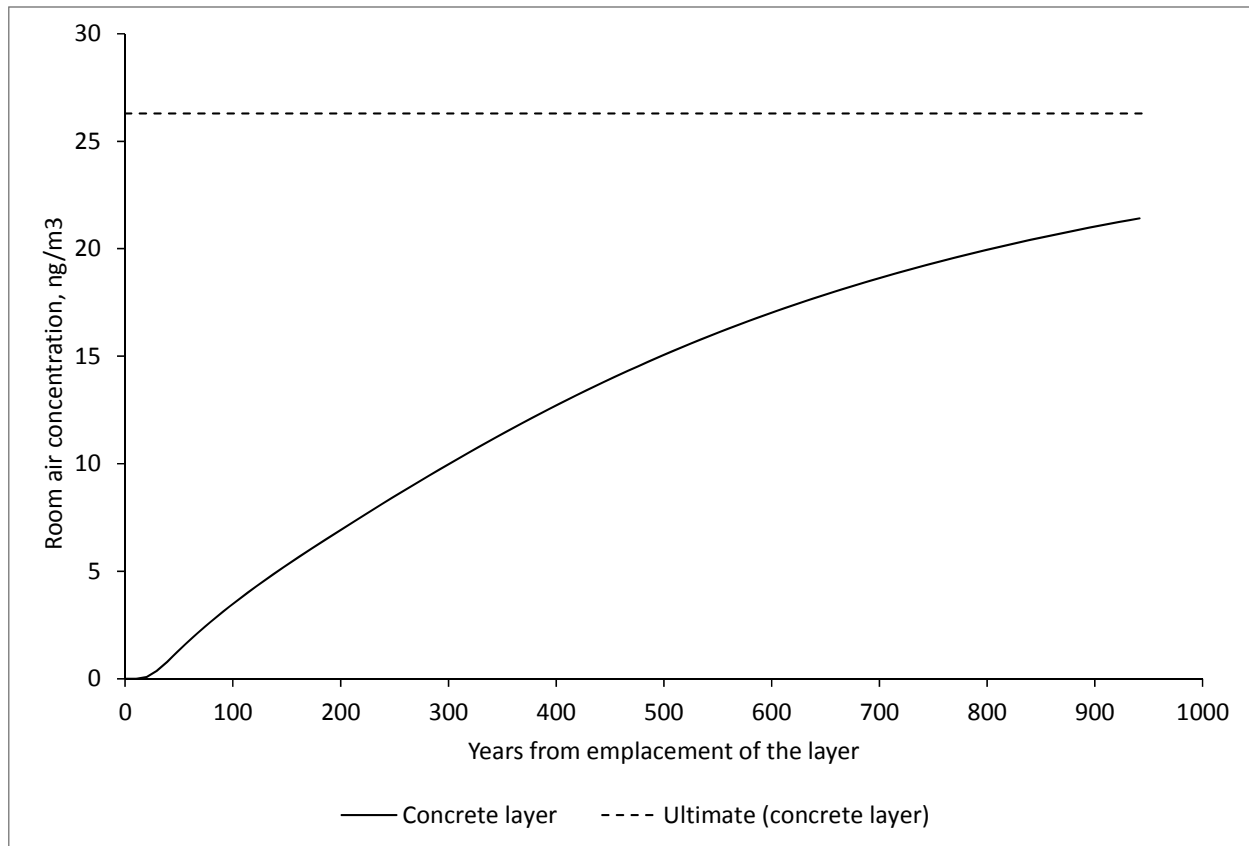
However, these equilibrium values are highly theoretical, since they would not be achieved for centuries. The time course of total room air concentration is illustrated in the following figure:

As can be seen, the concrete layer takes centuries to reach equilibrium. The homologue profiles for the flux and room air concentration are also shifted substantially to the lower homologs during the earlier part of the equilibration time.
